The Safety and Enforcement Division (“SED”) of the California Public Utilities Commission conducted a G.O. 112, Operation and Maintenance Inspection of Southern California Gas Company's (“SoCalGas”) Harbor Corridor Distribution Area from April 29, 2019 to May 10, 2019. The inspection included a review of the company’s written O&M procedures pursuant to G.O. 112-F, Reference Title 49, Code of Federal Regulations (CFR), Parts 191, 192 and 193

2019 SoCalGas Harbor Corridor Distribution Area
4/29/2019 to 5/10/2019

Notice of Probable Violations

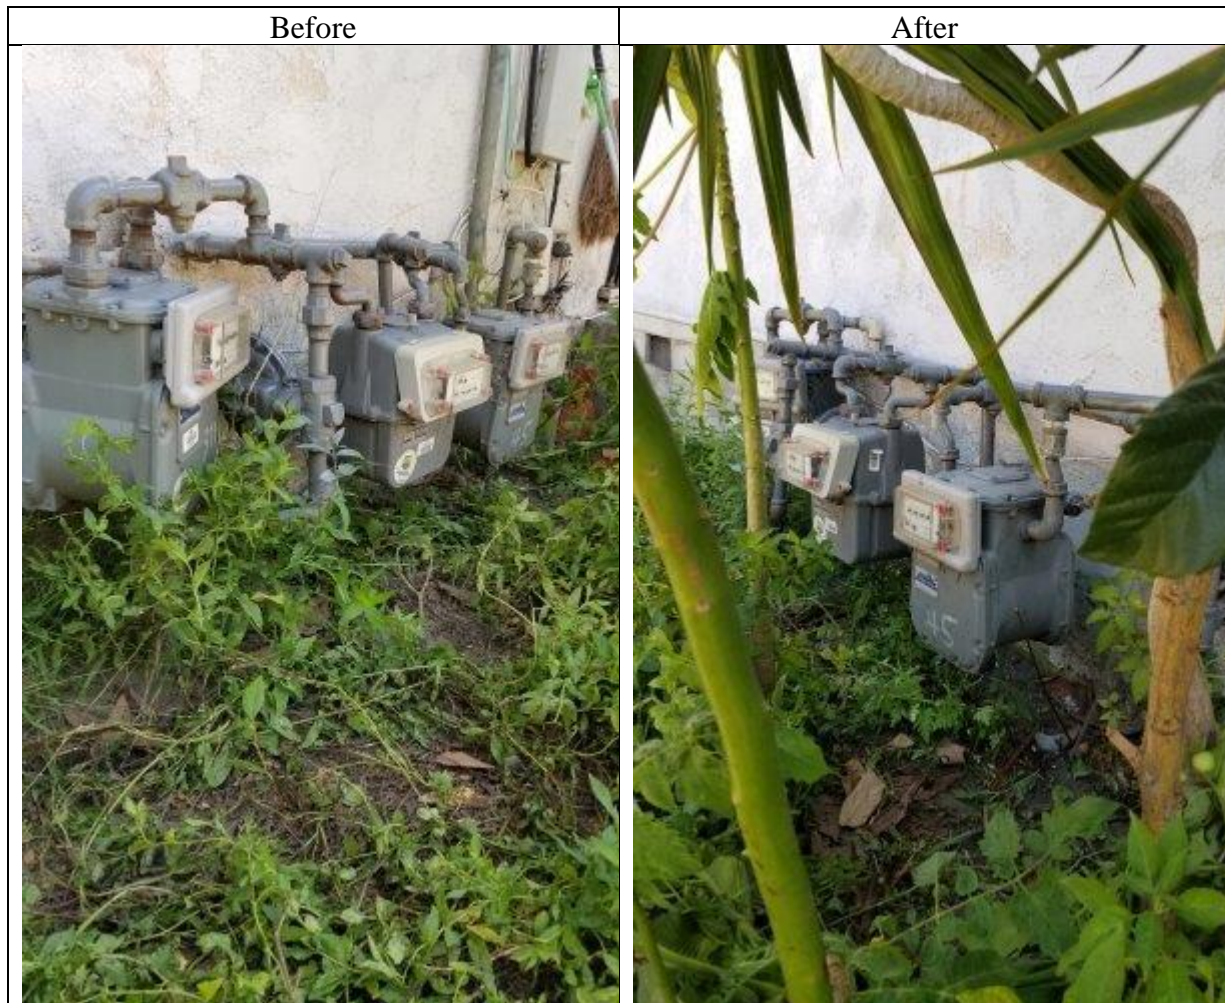
- a. 52-2129040 – 5145 Martin Luther King Blvd. Lynwood

2. On 5/9/2019, during a leak survey on Pope Ave in Lynwood, SoCalGas and SED observed a number of meters which were found to be slanted, and a number of manifolds which were not attached to a wall of a house. According to 49 CFR §192.357, meters should be installed to minimize anticipated stresses upon the connecting piping and the meter. Please provide a status update on the corrective action and completion of work order.

SoCalGas has completed the repairs. Attached are before and after pictures for the three identified installations below.
